Re: Tallyn Ridge – Combined Preliminary (AKA Glad Hill Property)  
File #S1166, Project Number 14144  
BCG Project # 5747-01-002  
FRO Staff Level Review

Issues associated with Specimen Tree 1- Refer to attached Photo Exhibit (Photo #s 1 – 25)

Issues associated with Specimen Tree 41- Refer to attached Photo Exhibit (Photo #s 26 – 36)

Issues associated with Specimen Trees 17, 18, and 19- Refer to attached Photo Exhibit (Photo #s 37 – 41)

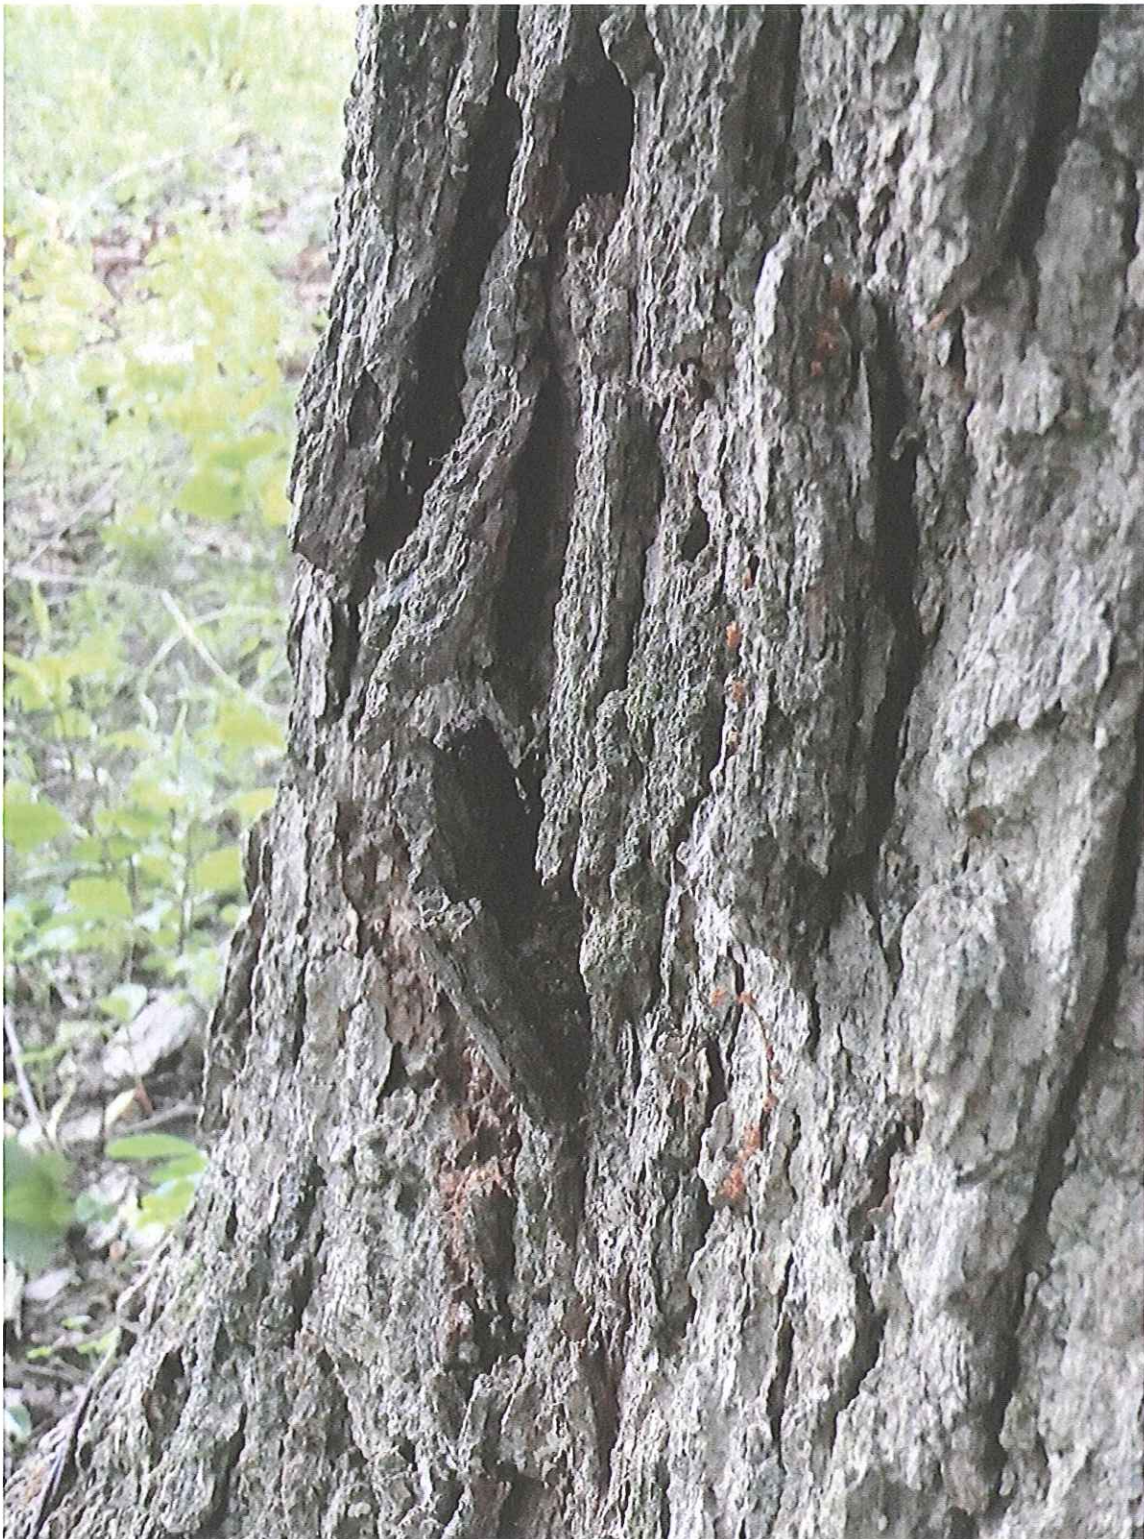
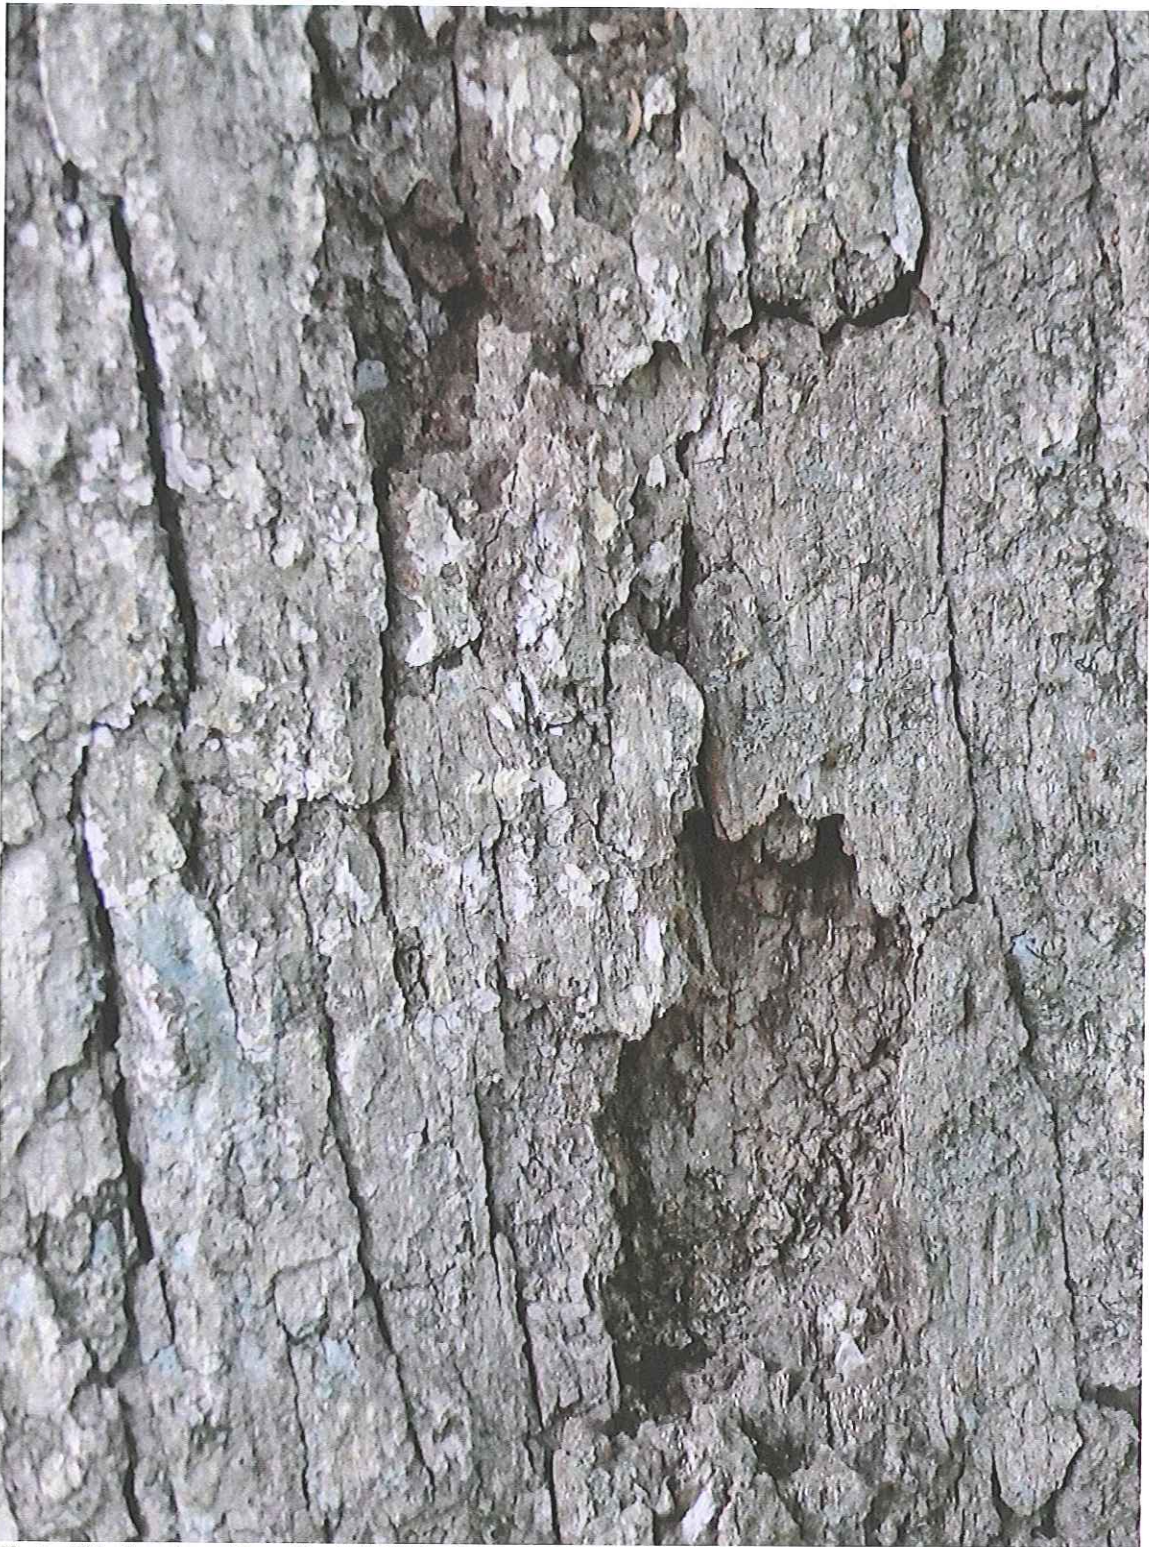
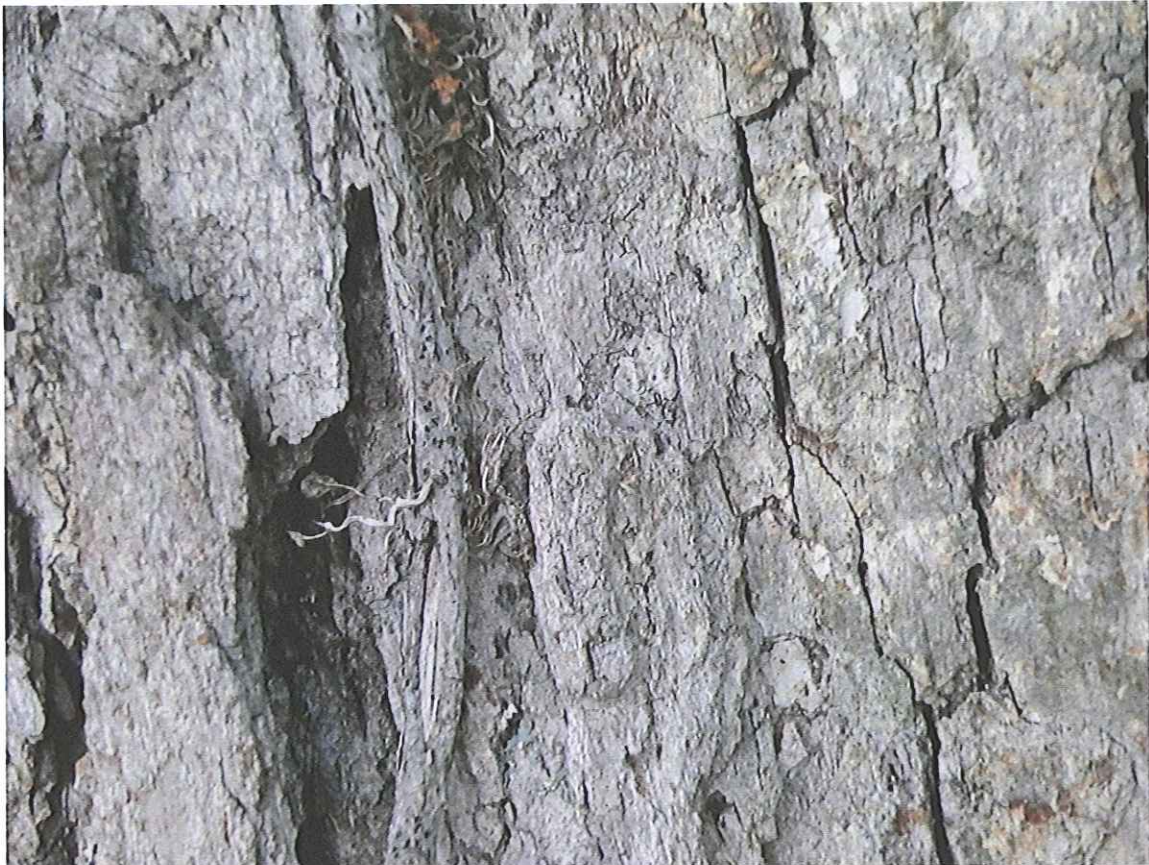
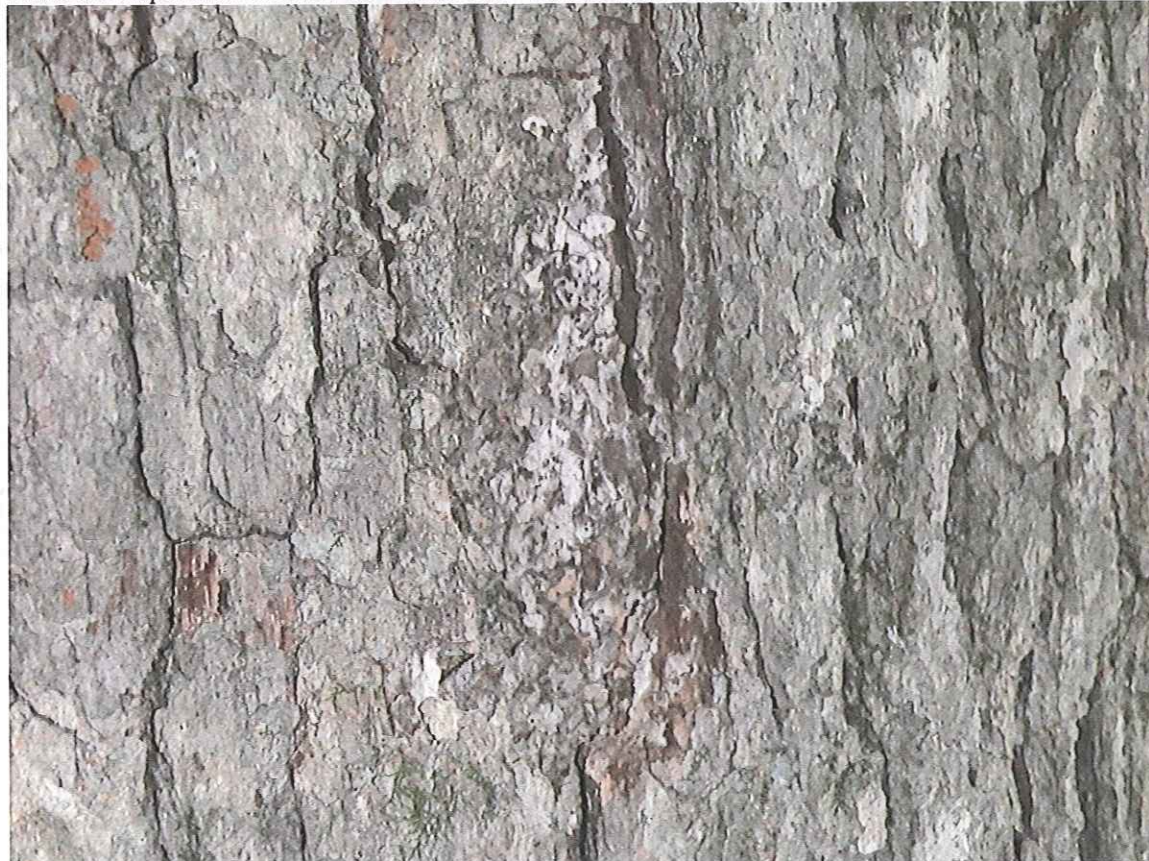
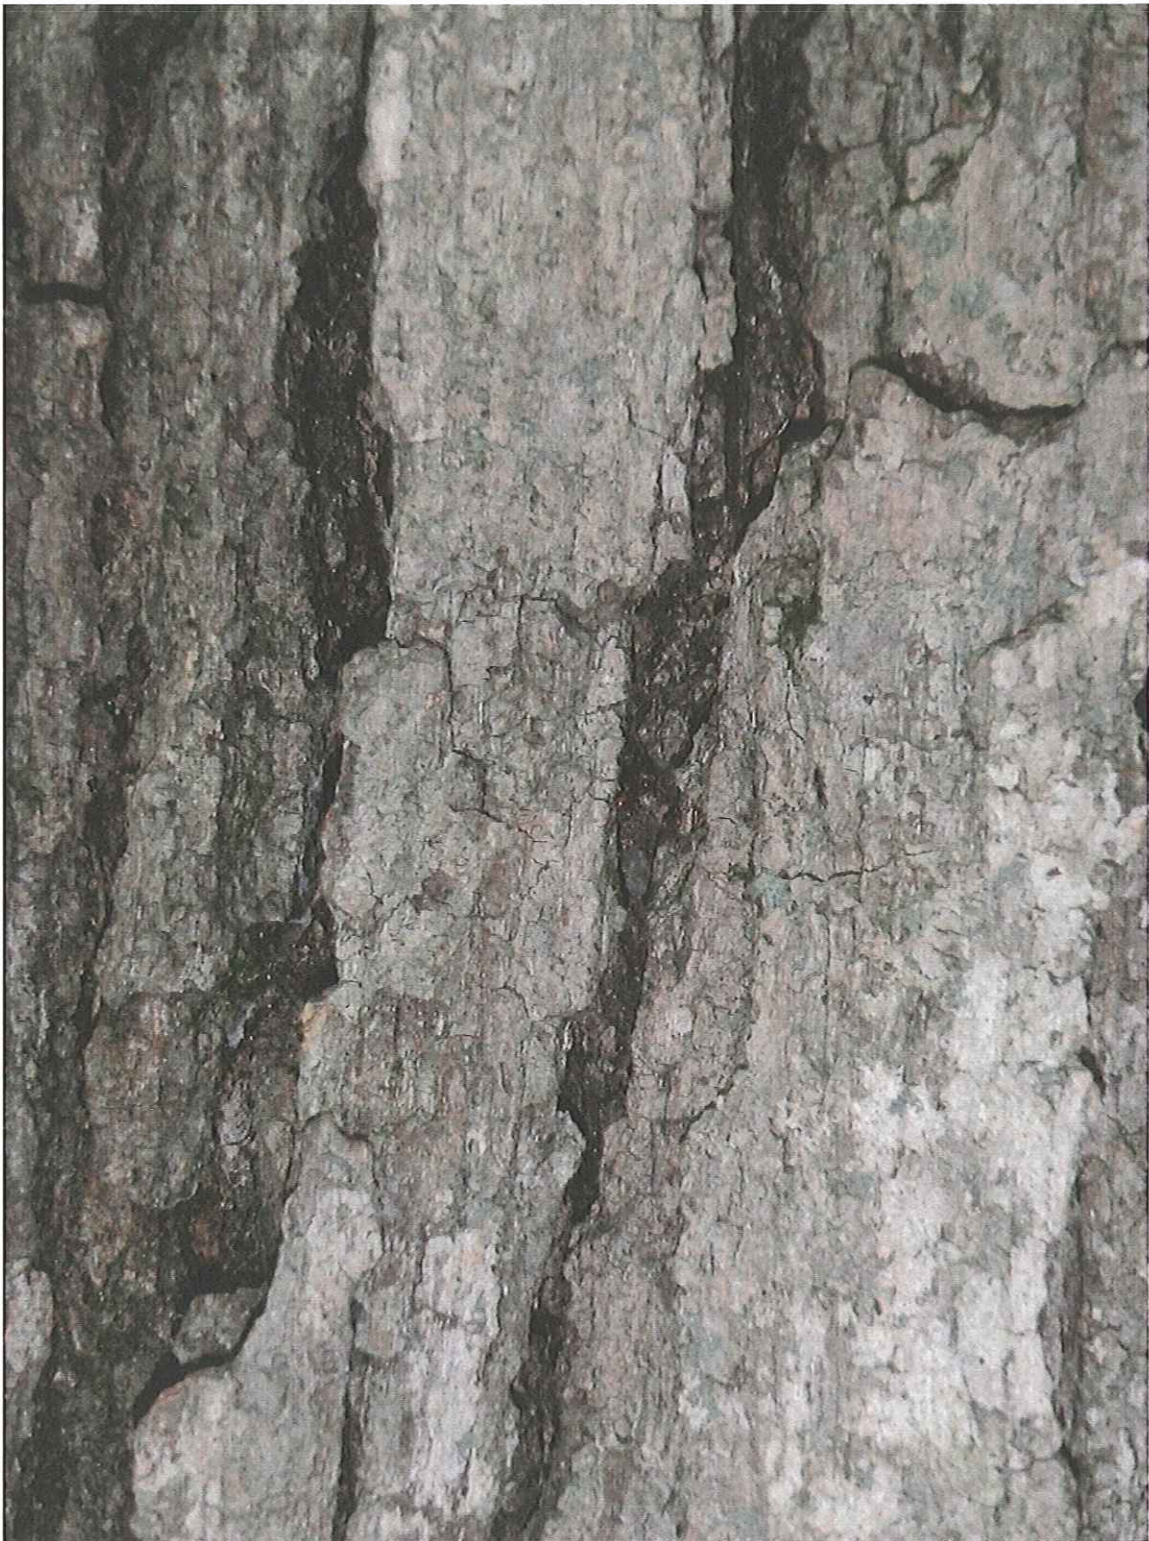
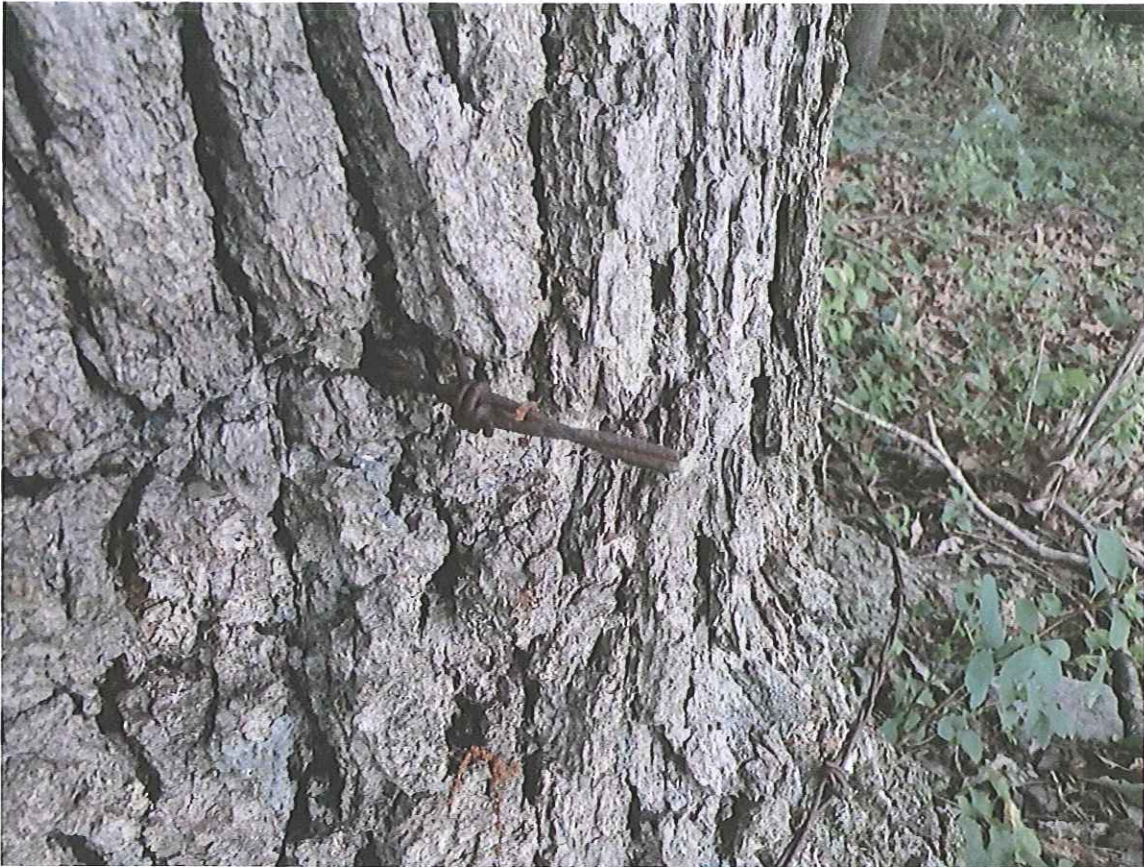
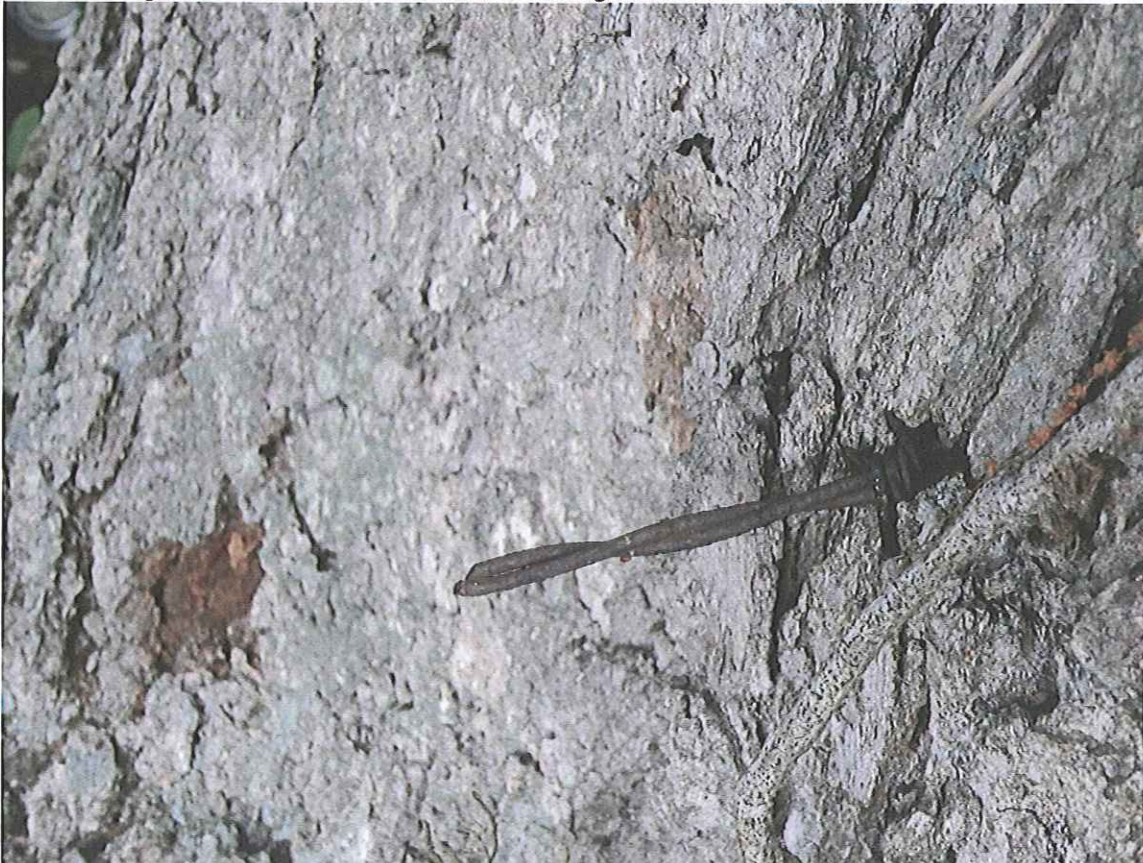
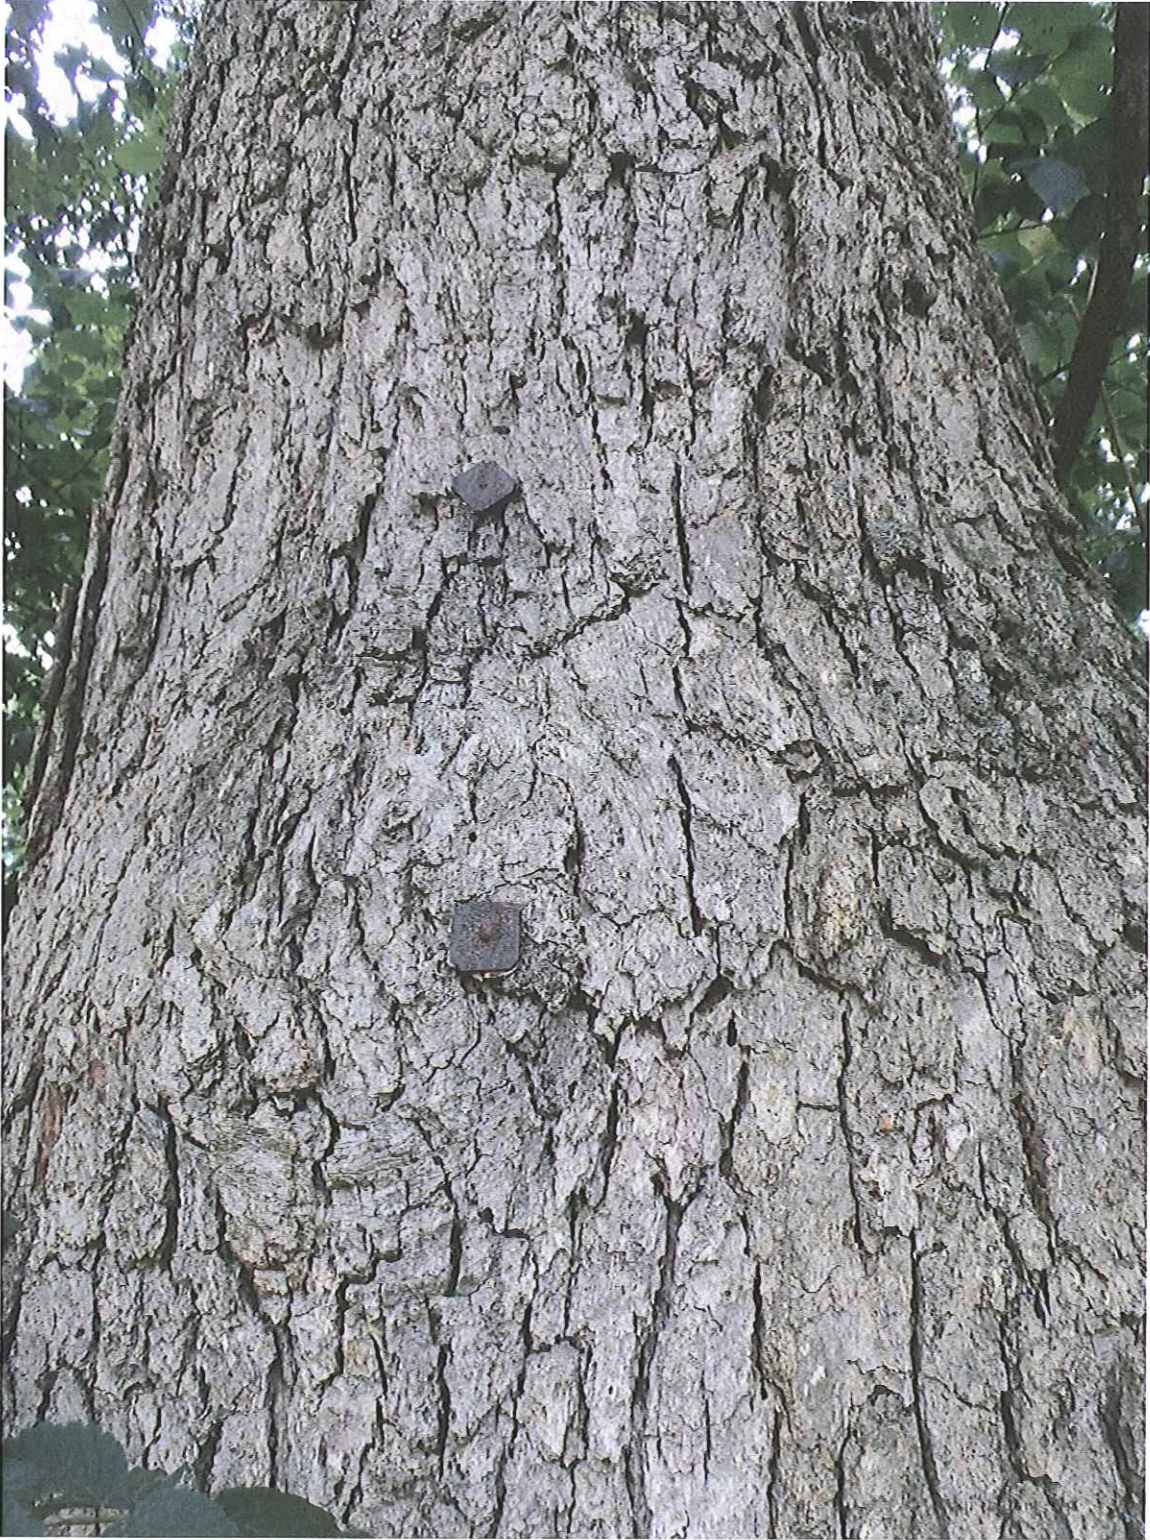
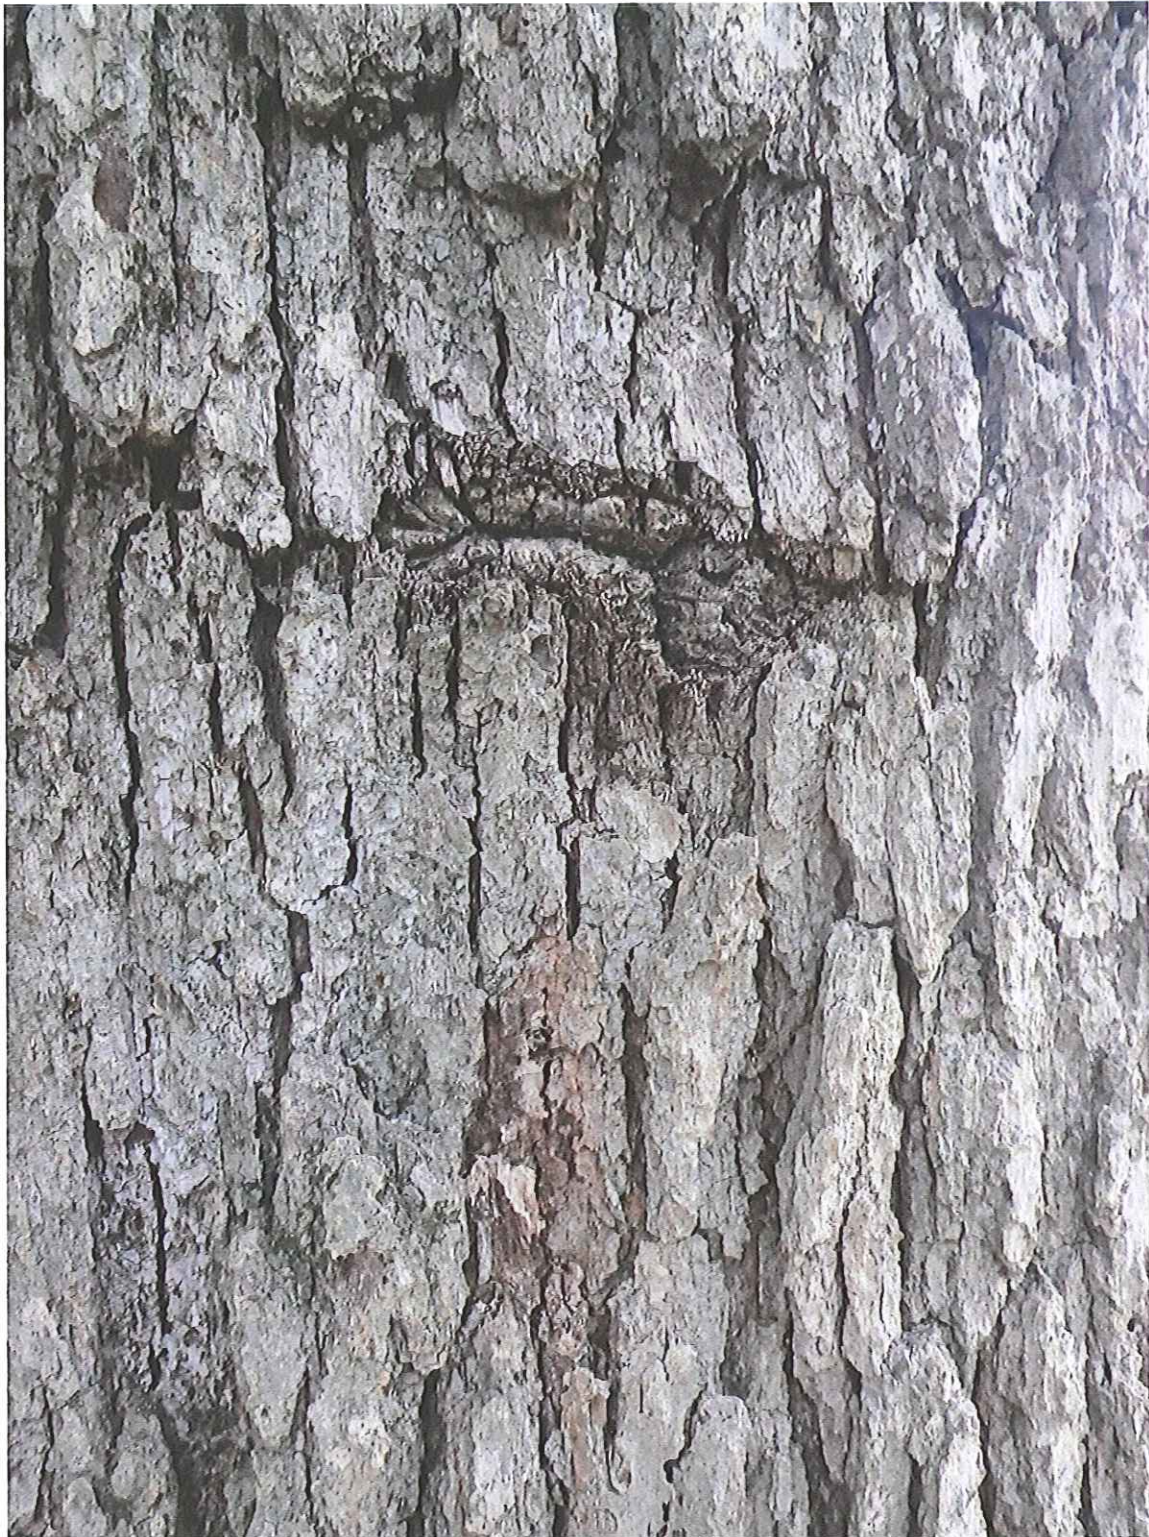
- Loose/Dead Bark - Root decay is often associated with loose or dead bark on the root collar.
- Active insect infestation – Presence of carpenter ant colonies indicate a presence of dead wood and decay.
- Damage from barbed wire and bolts - Trunk wounds provide entry for wood-rotting fungi that reduce the volume of sound wood and increase the probability of stem breakage.
- Multiple seams - Potential indicator of tree decay. Vertical cracks can be caused by a variety of reasons, may be associated with decay and will eventually fail. They suggest an internal defect, usually an old wound. The wound creates a weakened place in the wood that is prone to cracking and splitting, especially when the trunk is under stress by winds or abrupt changes in temperature. Horizontal cracks indicate that the tree is already failing and should be removed as soon as possible.

**Photo #17:** Specimen Tree #1. 35" White Oak – Loose/Dead bark.

**Photo #18:** Specimen Tree #1. 35" White Oak – Loose/Dead bark.

**Photo #19:** Specimen Tree #1. 35" White Oak – Active insect infestation.

**Photo #20:** Specimen Tree #1. 35" White Oak – Active insect infestation.

**Photo #21:** Specimen Tree #1. 35" White Oak – Active insect infestation.

Photo #22: Specimen Tree #1. 35" White Oak – Damage from barbed wire and bolts.

Photo #24: Specimen Tree #1. 35" White Oak – Damage from barbed wire and bolts.

Photo #25: Specimen Tree #1. 35" White Oak – Multiple seams.

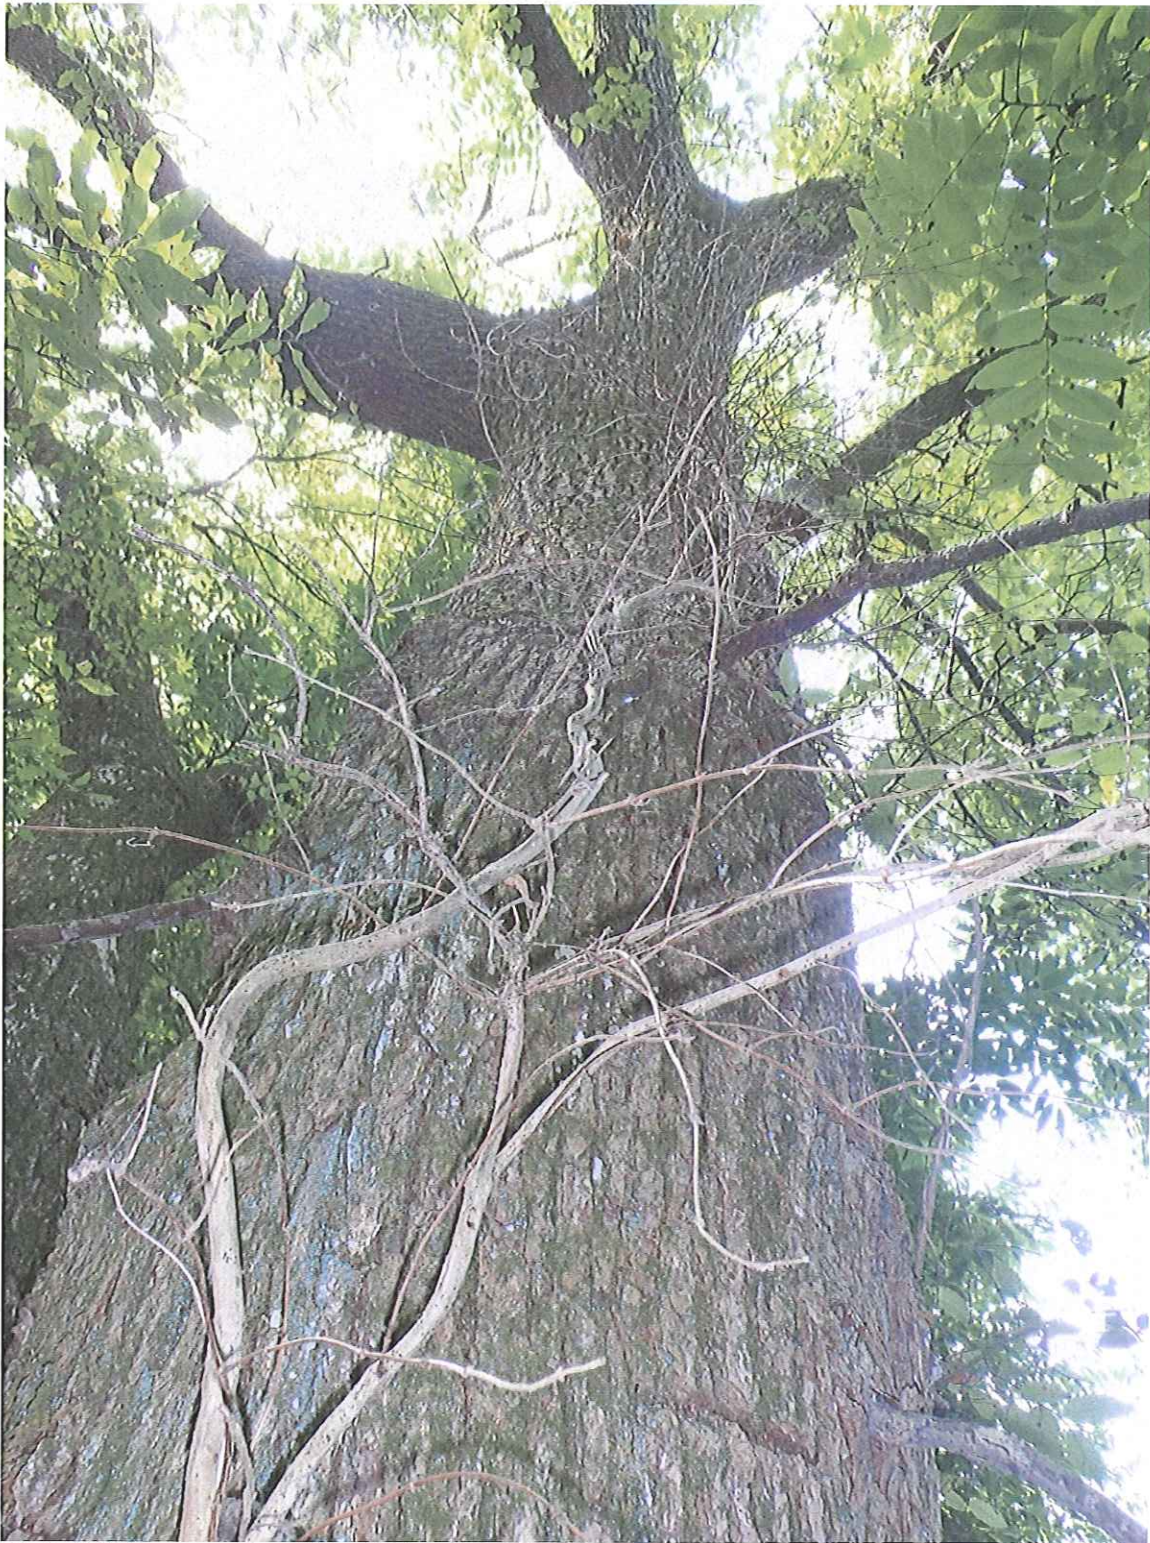
- Invasive vine cover – Can restrict light, add additional weight making the tree more susceptible to blow over during high rain, wind or snow events, strangle/choke and eventually kill the tree.

**Photo #26:** Specimen Tree #41. 30" American Elm – Invasive vine cover.

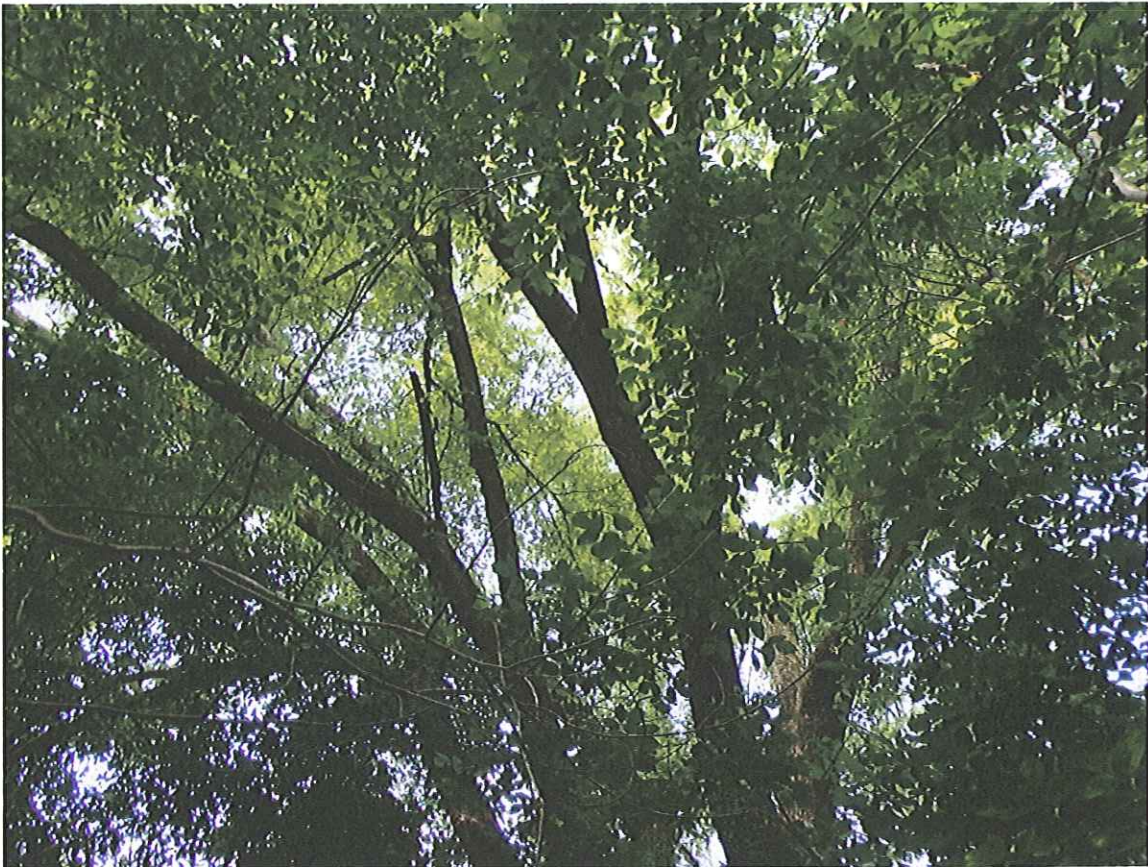
- Dead wood throughout canopy - Poses potential hazard to life and/or property on proposed adjacent community when located in the open or along forest edge.

Photo #27: Specimen Tree #41. 30" American Elm – Dead wood throughout canopy.

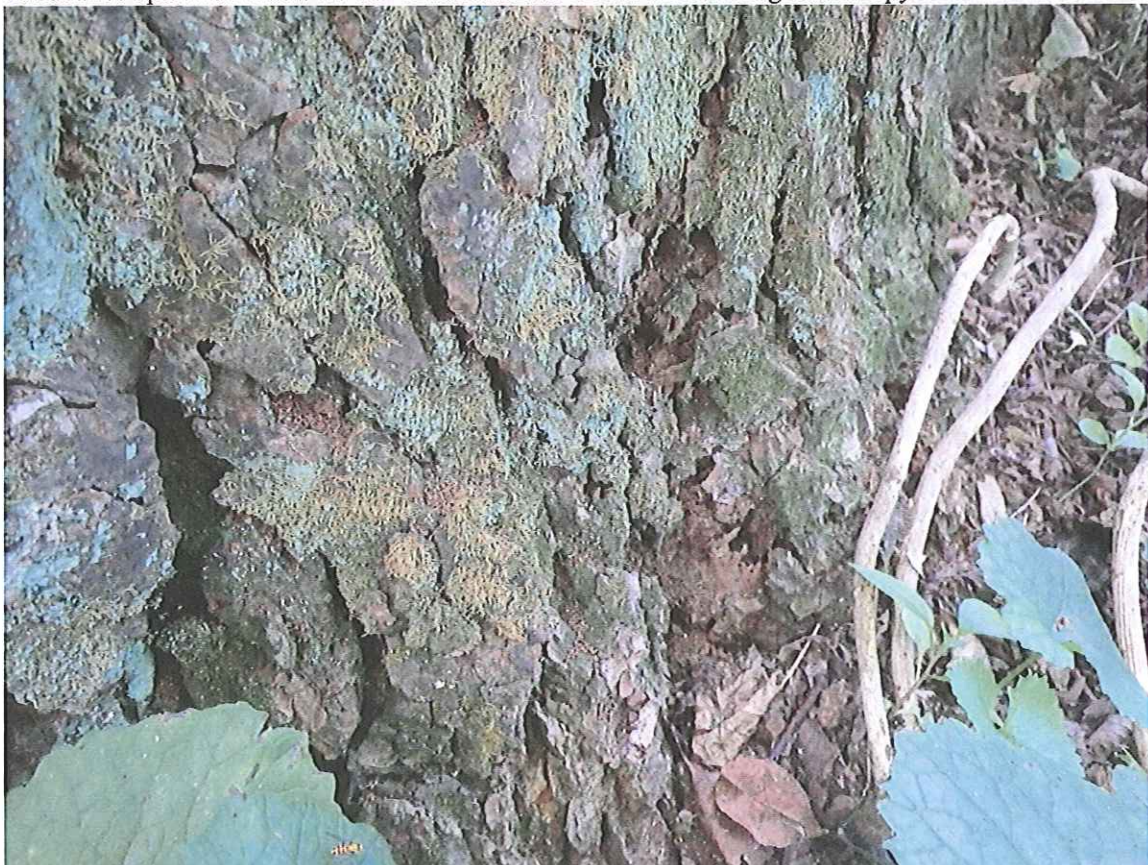
- Moss and deterioration at base - Deterioration in combination with moss at the base of tree could be a sign of root damage, which could increase the chance for tree failure. Wood rotting fungi destroy wood fiber in the root system, greatly reducing strength and resistance to wind throw.

Photo #27: Specimen Tree #41. 30" American Elm – Moss and deterioration at base.

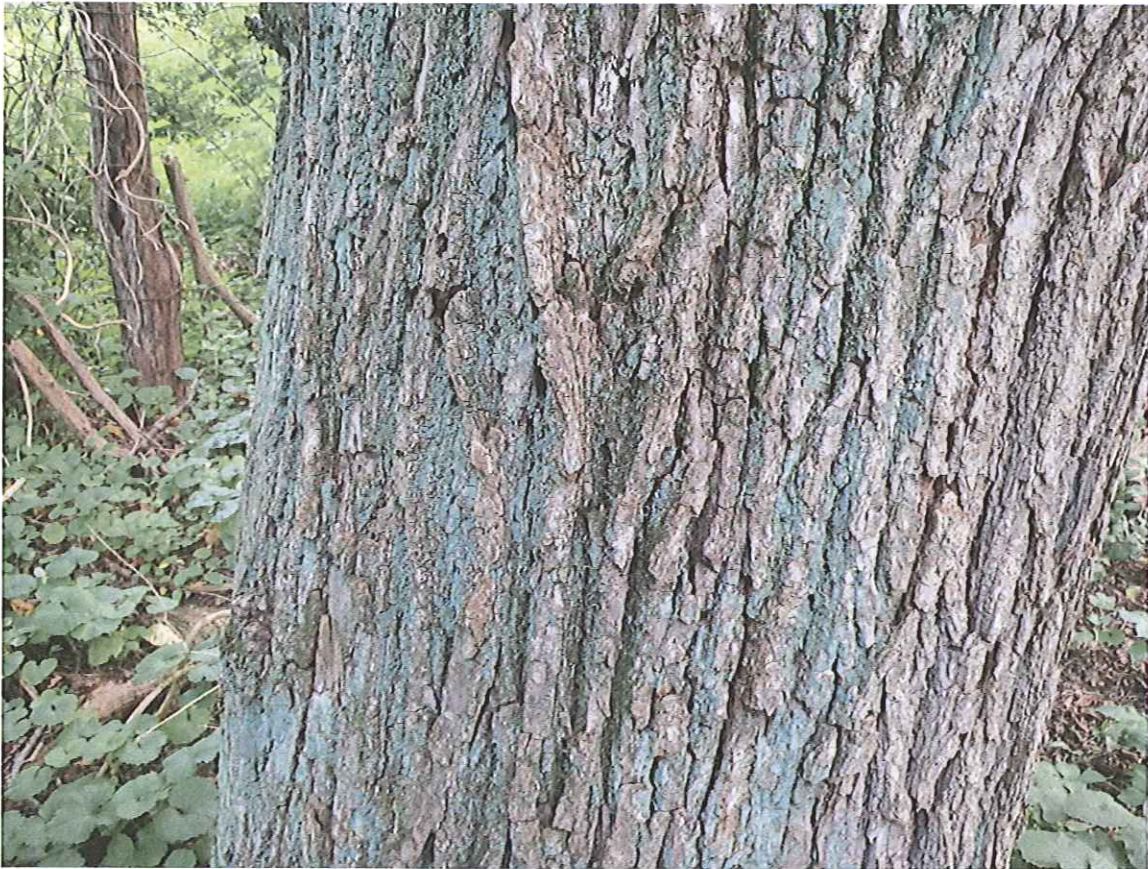
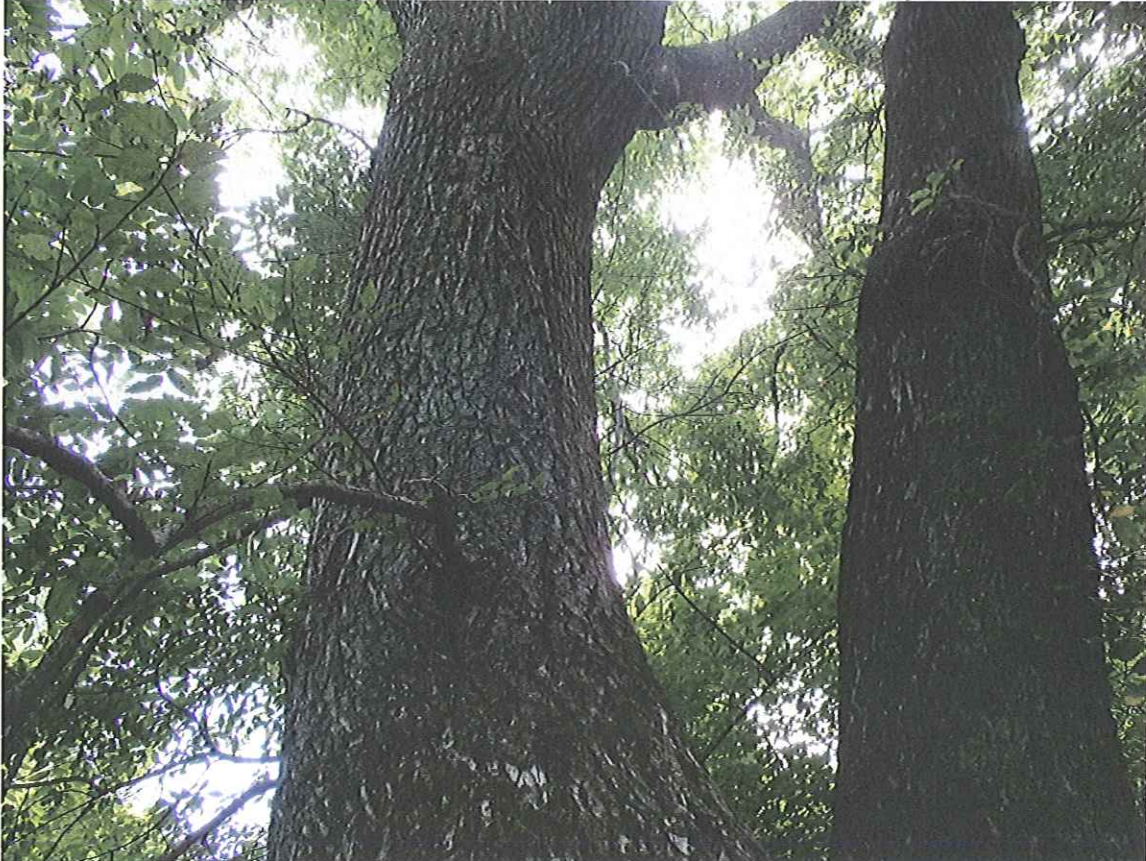
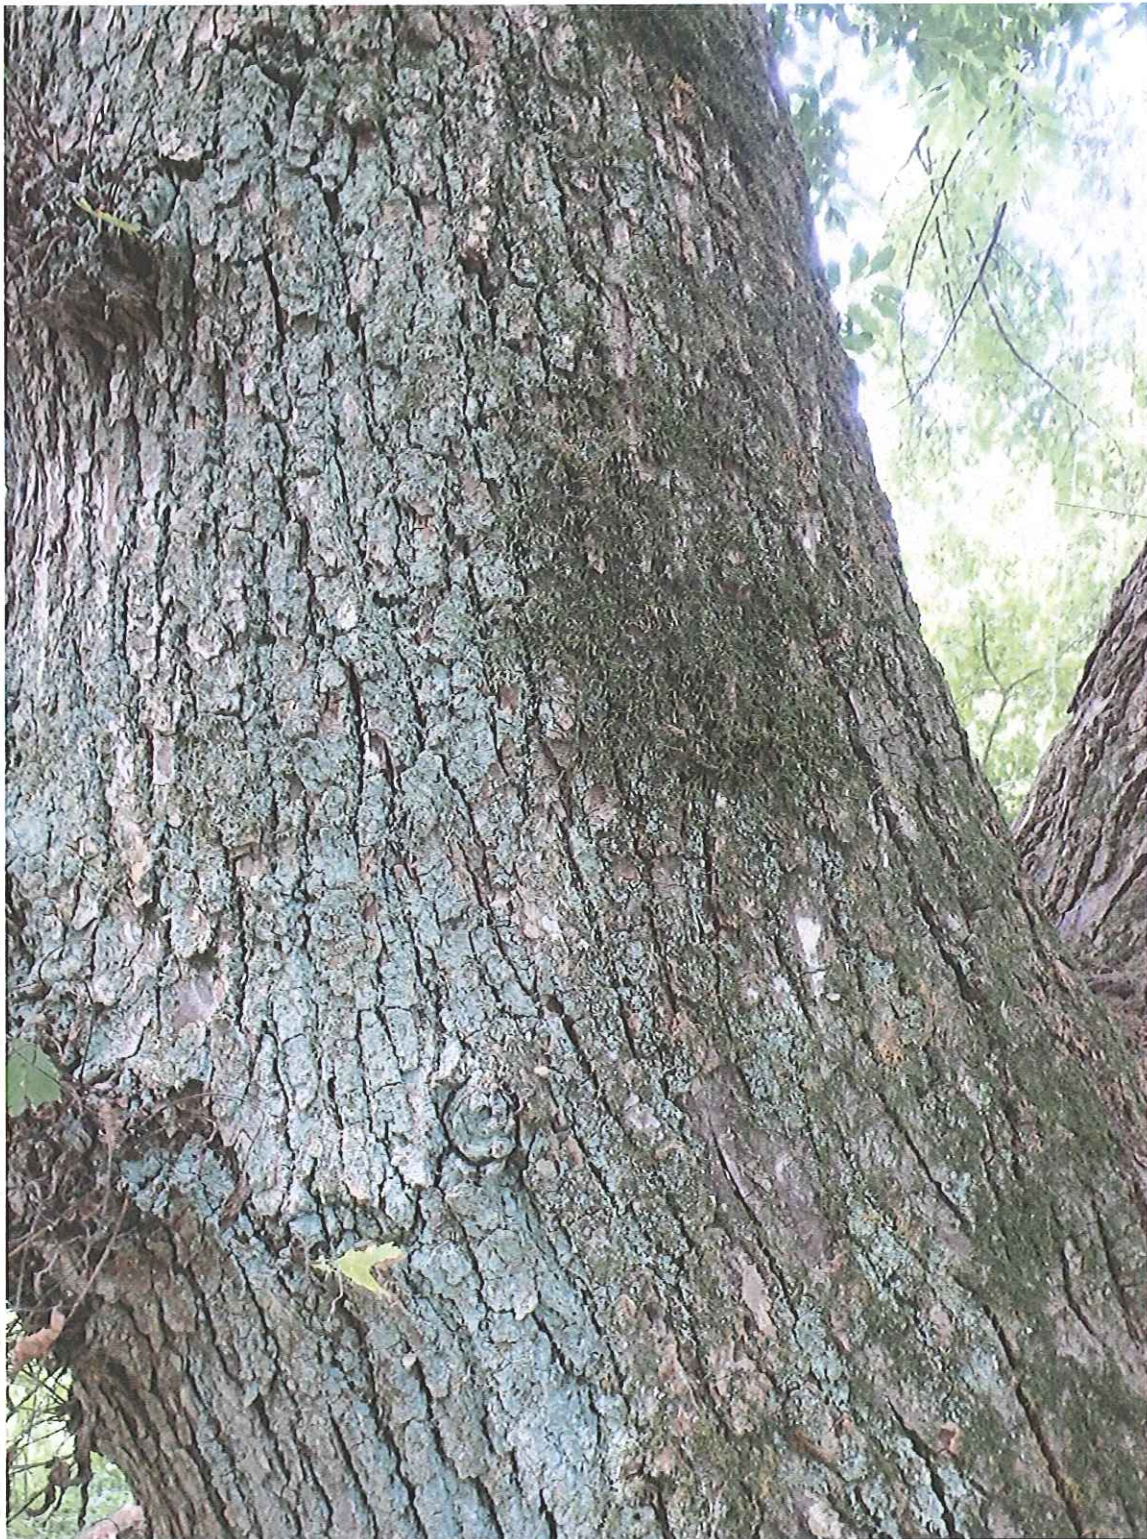
- Moss, lichens and fungi throughout limbs and trunk – Fungi, in most cases, are involved in tree diseases that result in the tree becoming a hazard. A wound occurs, fungus enters the wound and causes a discoloration of the wood, or it begins to rot roots directly with no wound required. Enzymes produced by the fungus decay the wood, weakening wood

fibers. Wood on the internal portions of the trunk or limbs lose strength. Or, the root structure is so weakened that the physical support is greatly reduced. Limbs and small twigs die. The fungus begins to reproduce by forming a mushroom, conk, or shelf-like structure directly on the limbs, trunk, butt, root flares or on roots at some distance from the base of the tree. Larger limbs die and may fall. In the case of root rot, the entire tree may topple in a wind storm. Moss and lichens, when present with other symptoms of decline, often indicate excess moisture within the root zone. The presence of the moss and lichens on the roots and within the root collar also create

Photo #28: Specimen Tree #41. 30" American Elm – Moss, lichens and fungi throughout limbs and trunk.

Photo #29: Specimen Tree #41. 30" American Elm – Moss, lichens, and fungi throughout limbs and trunk.

**Photo #30:** Specimen Tree #41. 30" American Elm – Moss, lichens, and fungi throughout limbs and trunk.
